4.1.1.4 Bloemfontein urban area – Conclusions (Appendix A: Map 1)

Figure 23: Panorama of remaining Central Free State Grassland within the MOSS to the east of Botshabelo. Note low percentage grass cover and visible sheet erosion.

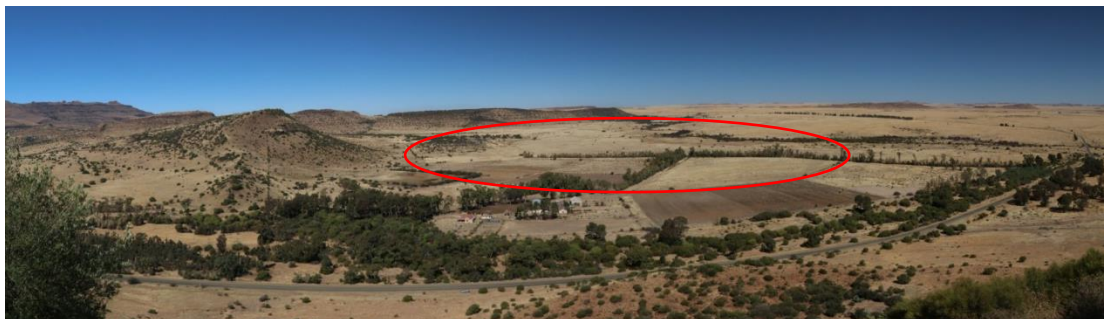
Figure 24: Another panorama of the grassland to the east of Botshabelo. Note again a very short grass layer caused by heavy overgrazing.

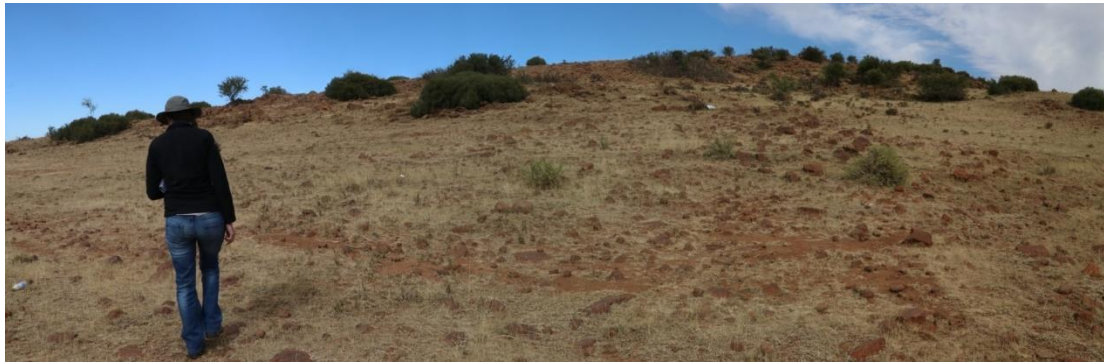
Figure 26: Panorama of one of small hills around Botshabelo. Here overgrazing is very high and the grass layer very short.

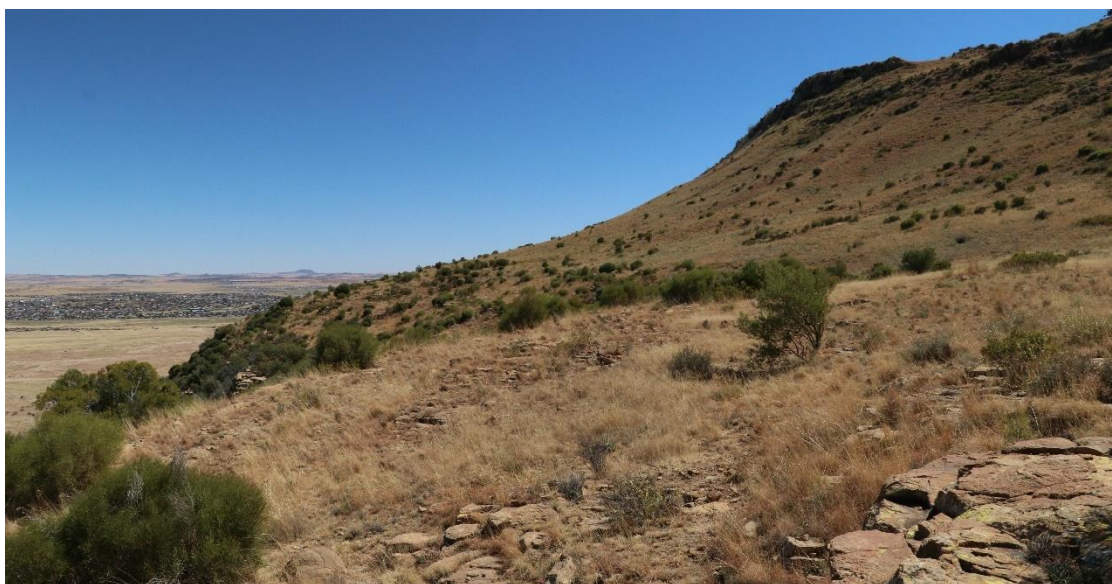
Figure 30: View of a portion of the plateau where a more prominent grass layer is evident.

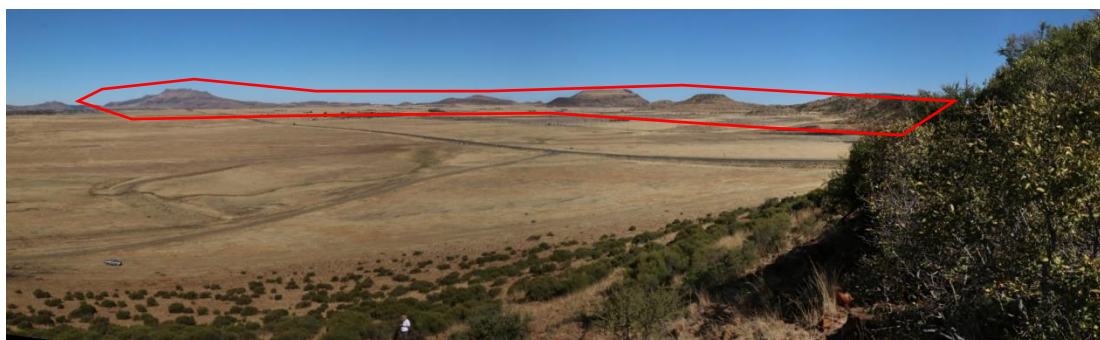
Figure 35: Panorama of MOSS around Thaba Nchu which clearly consists of the surrounding hills, ridges and mountains.

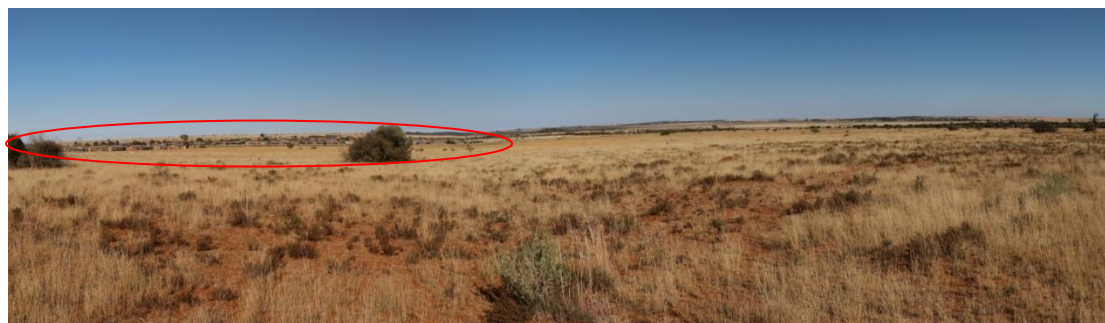
Figure 44: Panorama of the plains in the area. A well-developed but somewhat sparse, grass layer is evident with a prominent dwarf karroid shrub component visible. The urban area of Ikgomotseng is visible in the background (red).

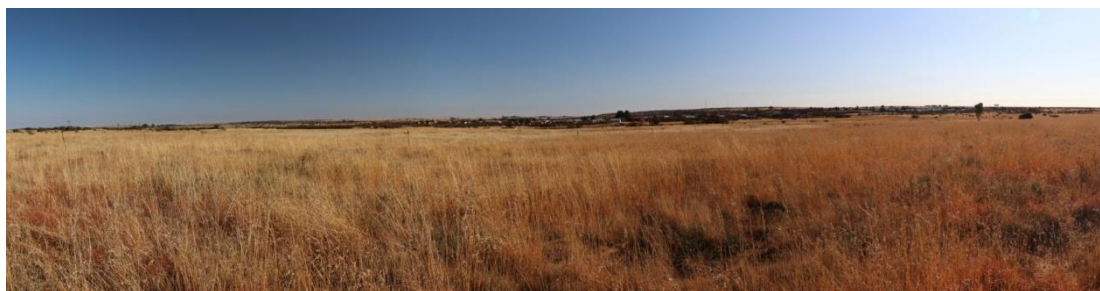
Figure 46: Panorama of the sandy grassland portion. A notably well-developed grass layer is present and the dwarf karroid shrub component is also much less prominent. It is therefore clearly distinguishable from the surrounding clay grasslands.

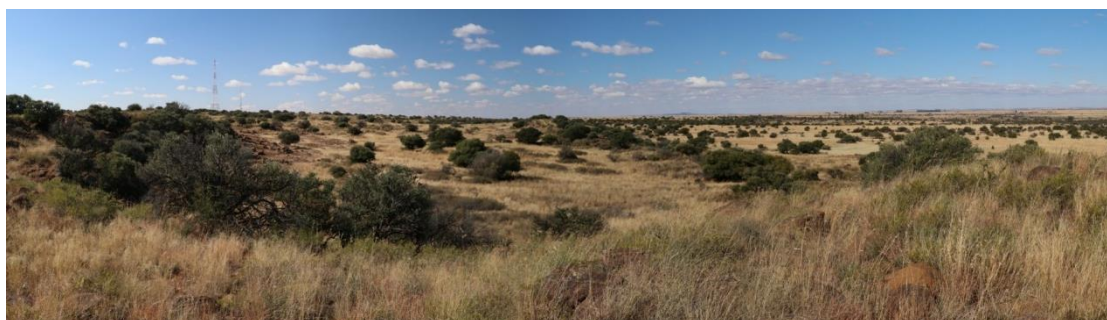
Figure 48: Panorama of the hill and ridge indicating the tree/shrub layer imbedded in a well-developed grass layer.

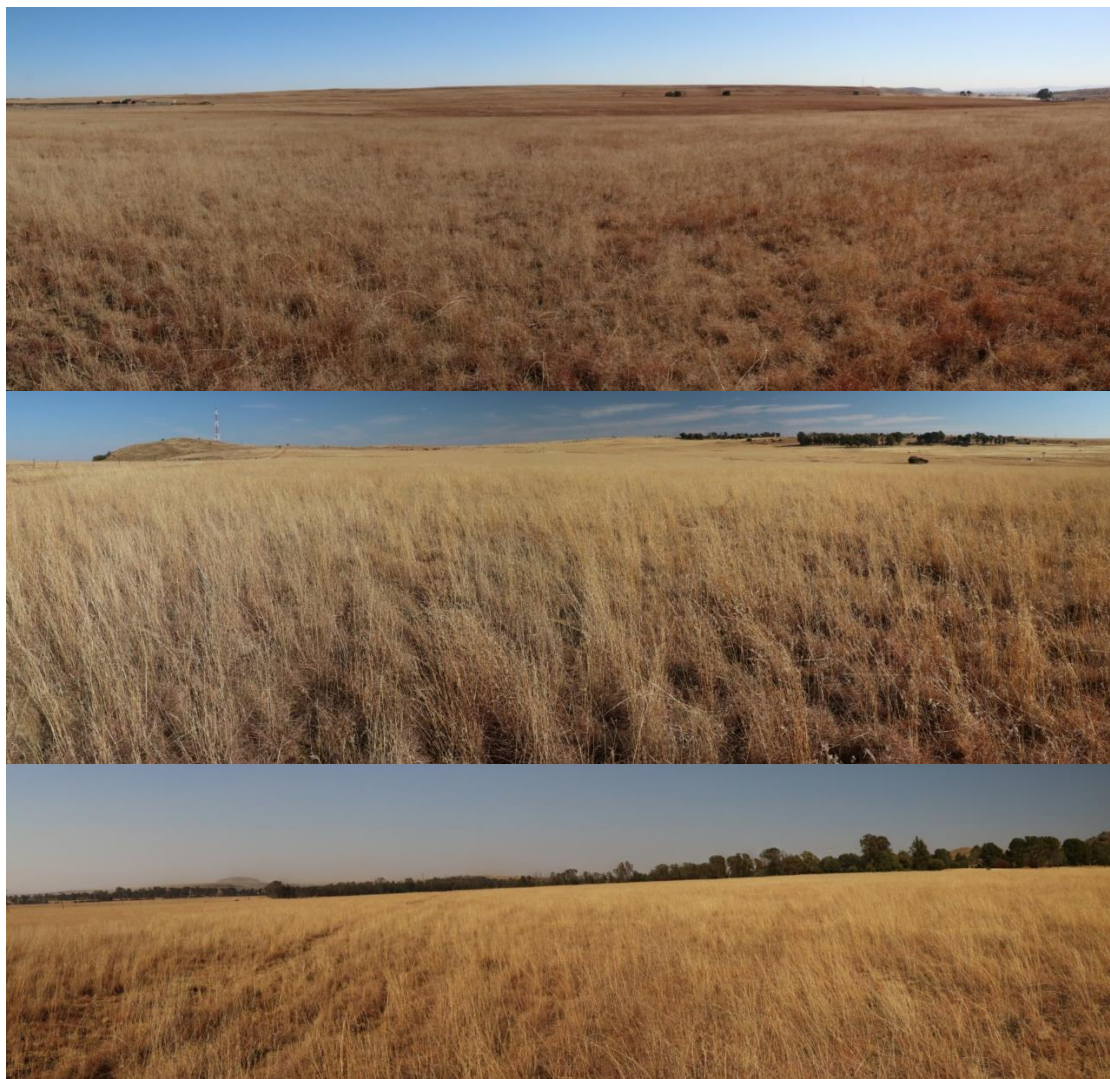
Figure 52: Three Panoramas of the plains in the area consisting of Central Free State Grassland. These panoramas are from top to bottom; south, west and north of the town and here a dense grass layer is evident. Although overgrazing is evident the impact is still moderate.

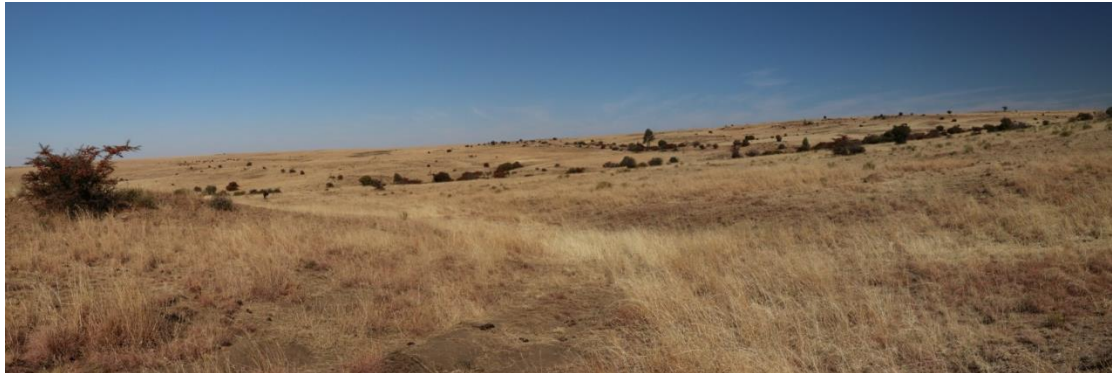
Figure 55: Panorama of the plains and sandstone ridges. A notably well-developed grass layer is present dominated by plains but with a visibly increased slope and elevation.

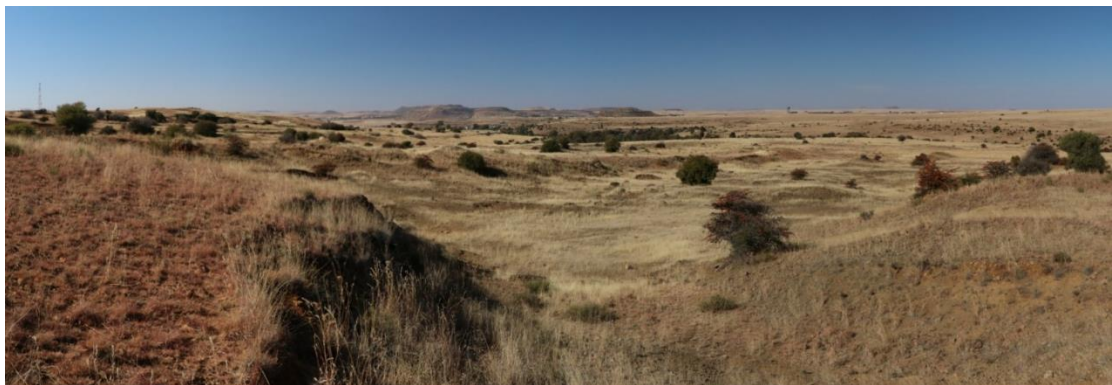
Figure 57: View of one of the old borrow pits which has caused transformation of the vegetation type.

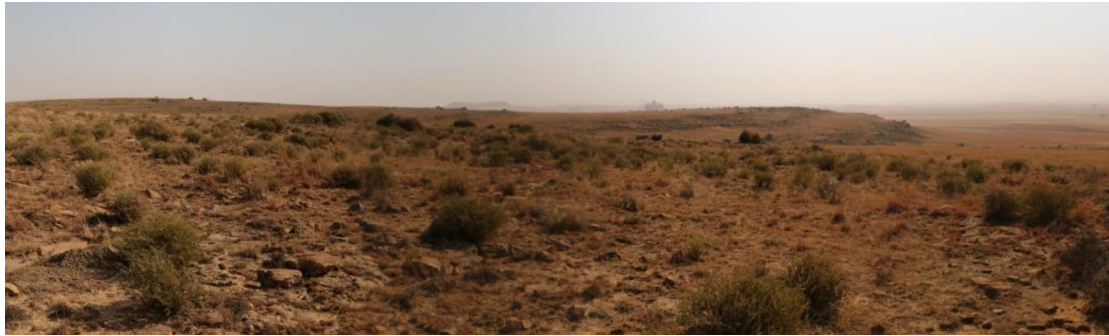
Figure 58: Panorama of the vegetation unit to the east of the town. Note again the increase in dwarf shrubs and sandstone outcrop though here overgrazing is quite severe.

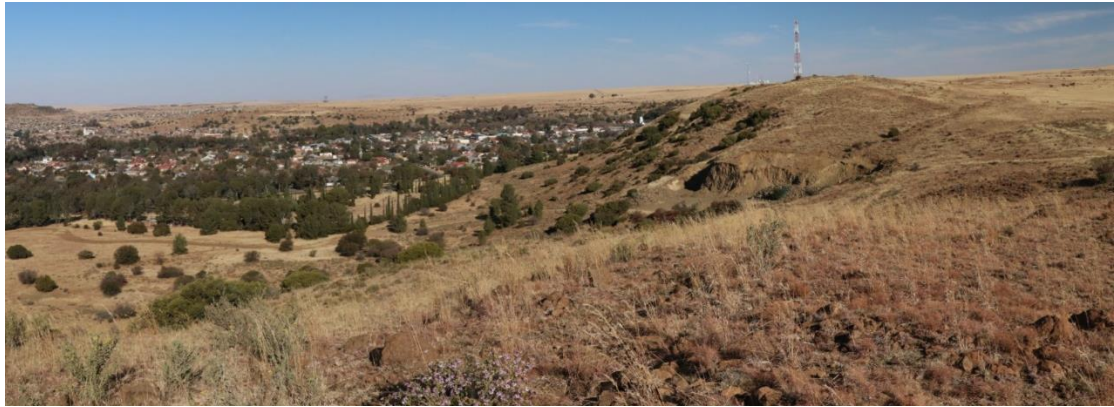
Figure 60: Panorama of the ridges system to the west of the town. Note a much sparser vegetation cover with a tree layer also becoming prominent along the slopes.

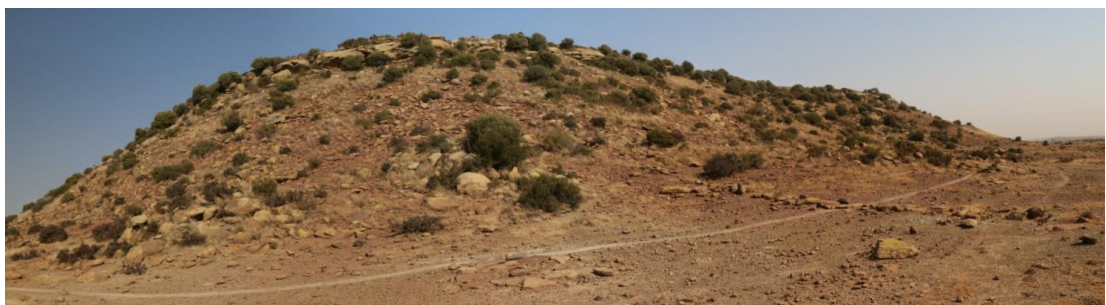
Figure 63: Panorama of the isolated sandstone hill to the east of the town. The survey has indicated that it has been significantly degraded by current land use.

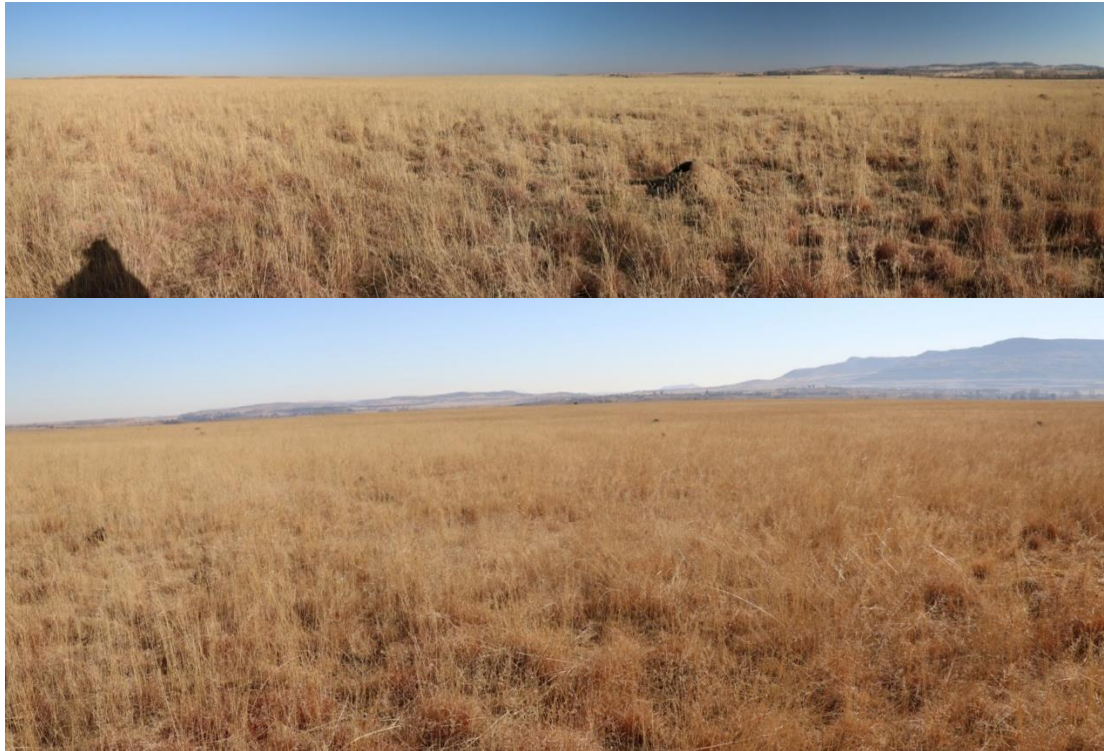
Figure 66: Panoramas of the plains in the area consisting of Aliwal North Dry Grassland. Note a dense grass layer without any shrubs or trees and a relatively uniform topography.

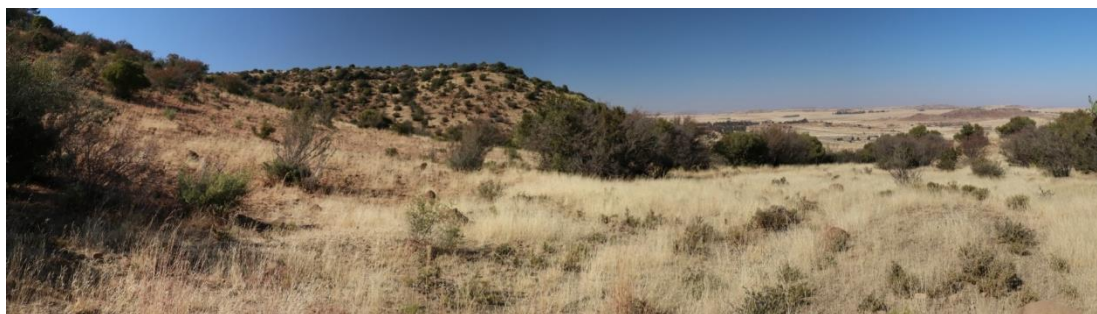
Figure 70: Panorama of the ridges and slopes which are quite easily identified by the topography as well as the clearly visible shrub and tree layer.

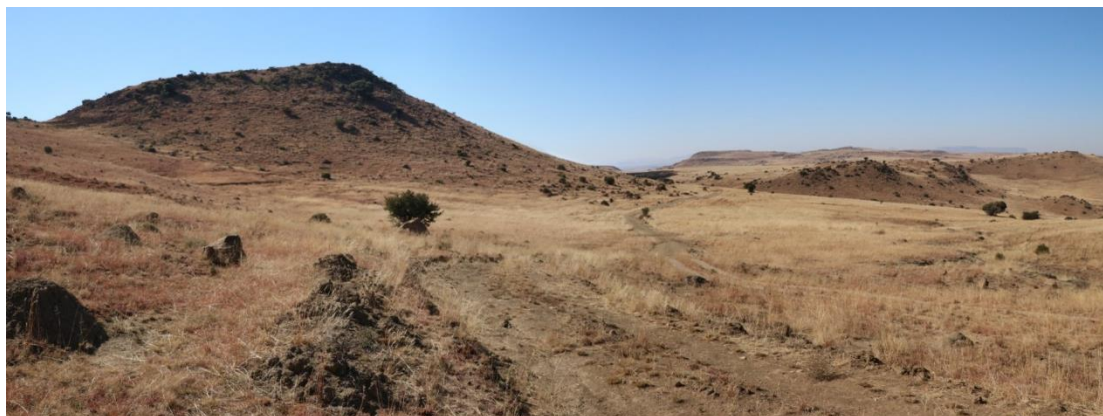
Figure 77: Panorama of the plateau with an undulating topography. Note low hills and outcrops are present and though a dense grass layer dominates, scattered trees are also present.

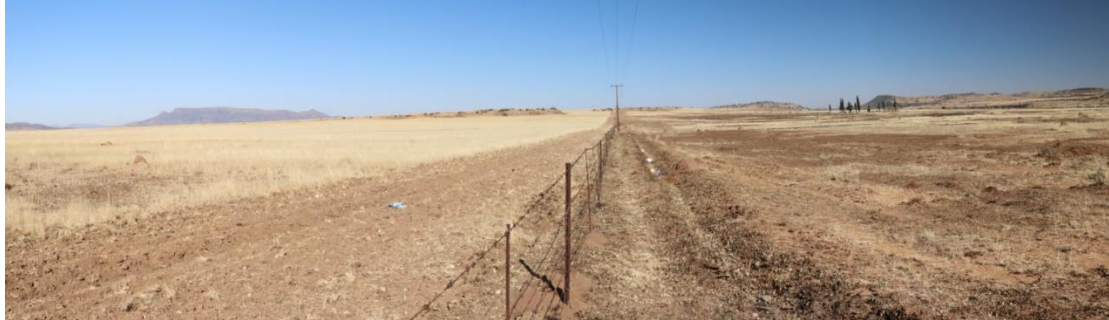
Figure 84: Panorama of the plains south of the town consisting of Aliwal North Dry Grassland. Note the stark difference between the sparse grassland in the municipal area compared to the dense grassland of neighbouring areas.

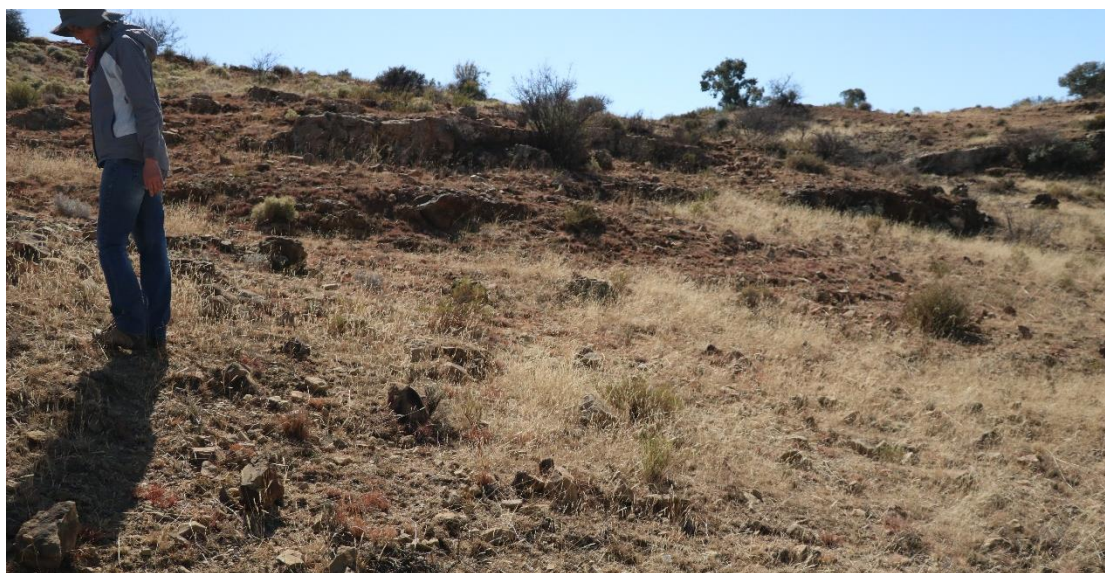
Figure 88: View of a west facing slope of the ridge system. The grass layer is notably dominated by pioneer grasses here, a consequence of overgrazing.

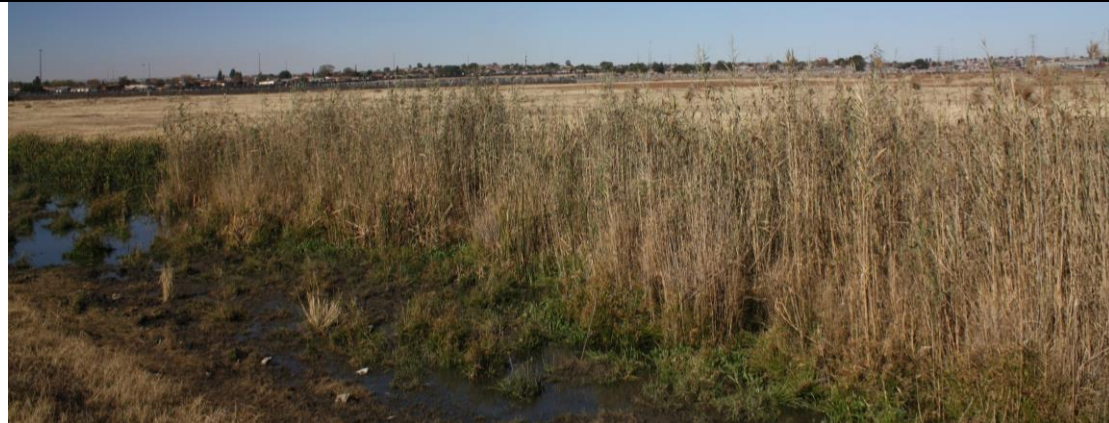
Wetland conditions has clearly developed along the dam wall.

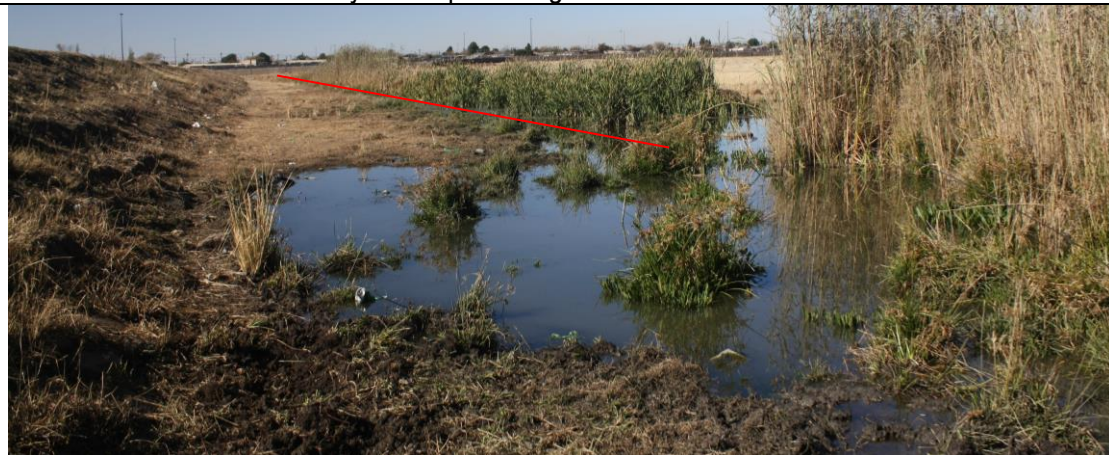
View of the dam, resultant wetland conditions and the overflow channel (red).

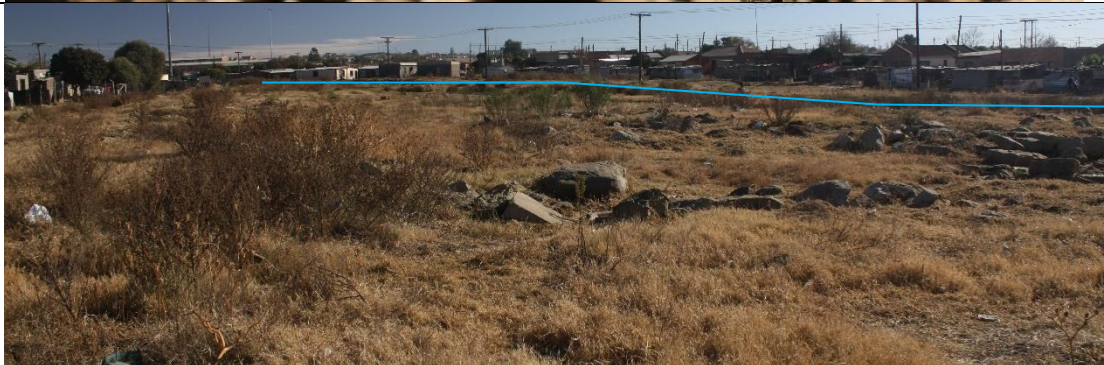
Note close proximity of urban area. The upper and lower zones are also notably degraded.

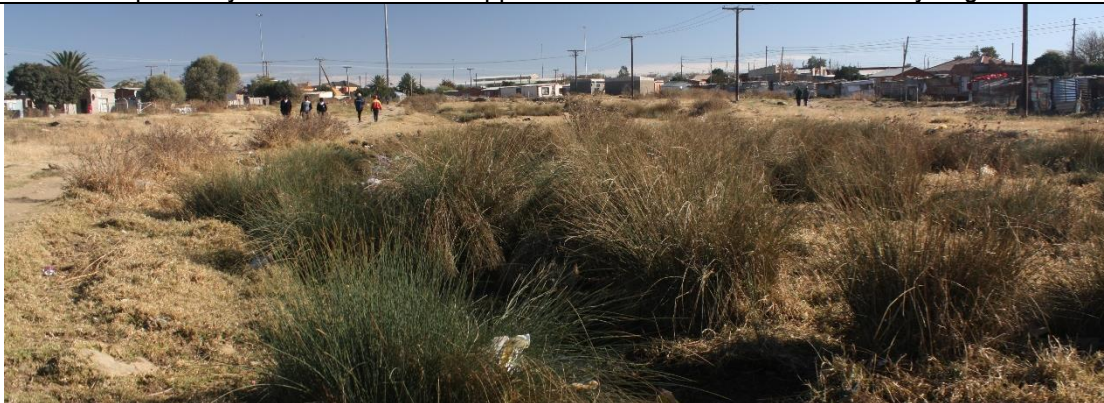
Note visible discoloration and opacity of water indicting pollutants.

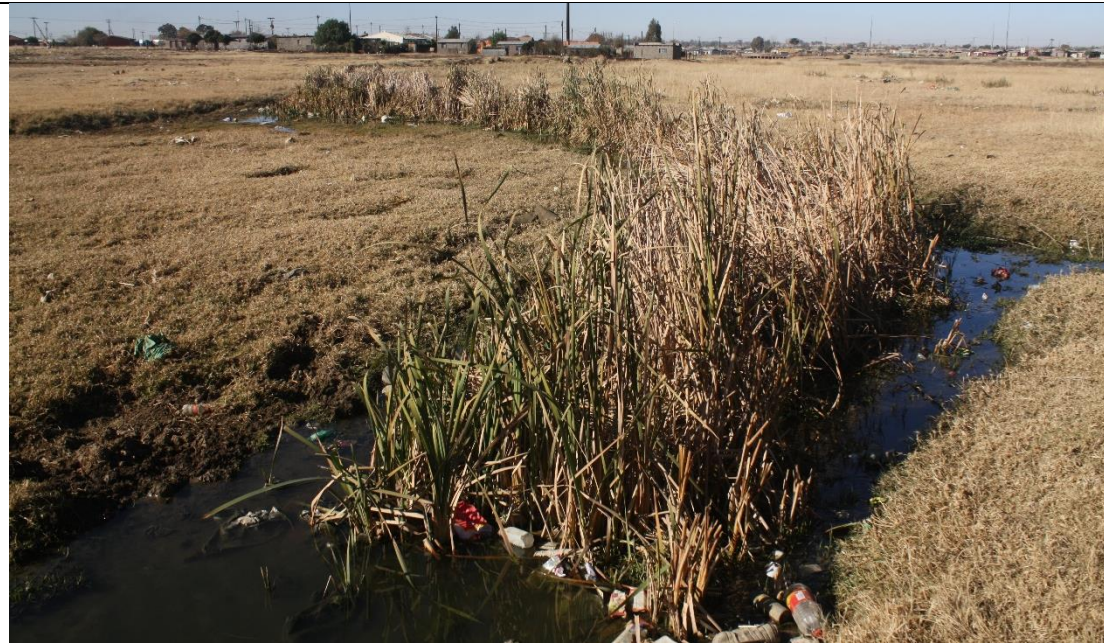
A clear main channel is present and wetland conditions evident. Note also rubbish dumping instream.

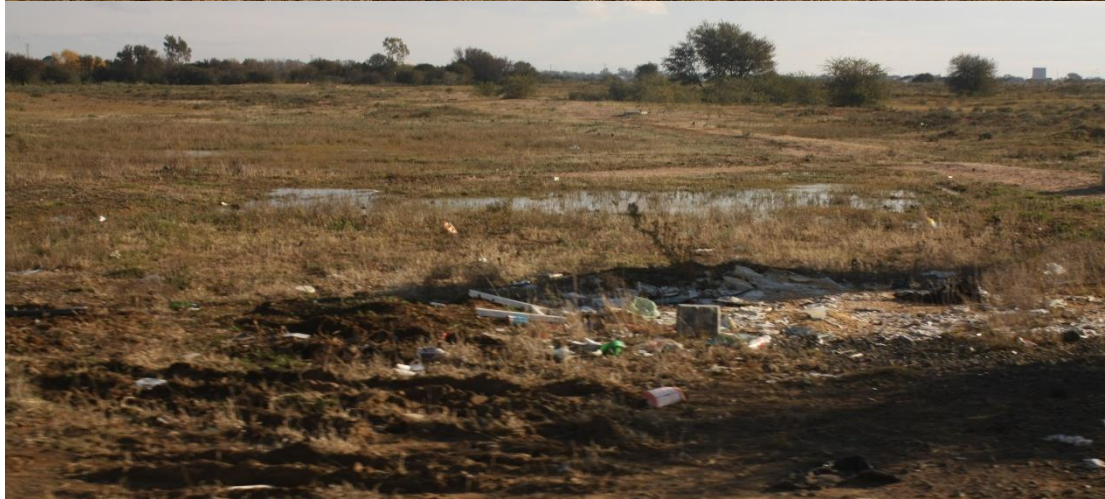
Large portions of the floodplain of the Bloemspruit has been degraded due to dumping of construction rubble and littering.

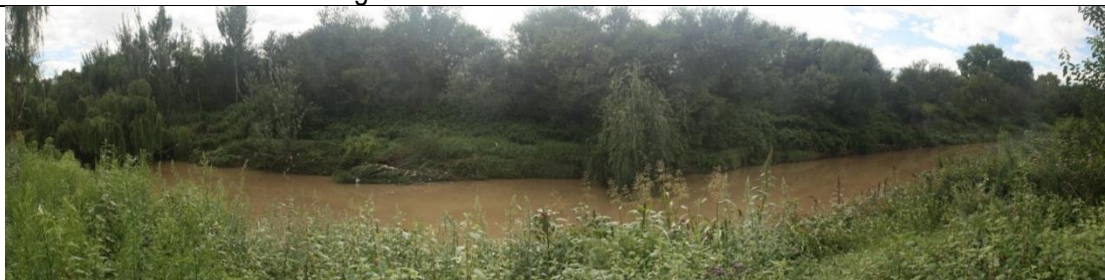
View of the Renosterspruit. Note that riparian vegetation consists almost exclusively of exotic vegetation.

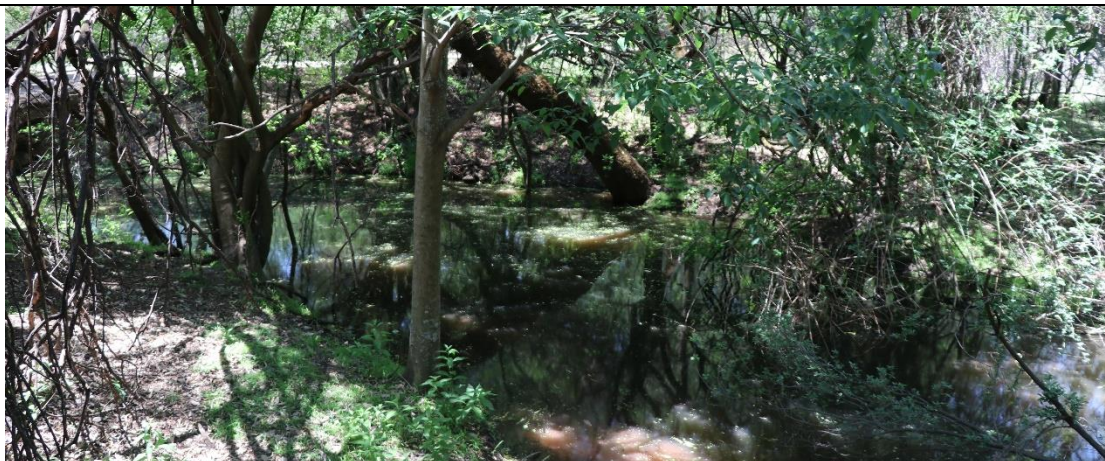
View of the stream in a downstream section, note that it increases significantly in width due to flow modification.

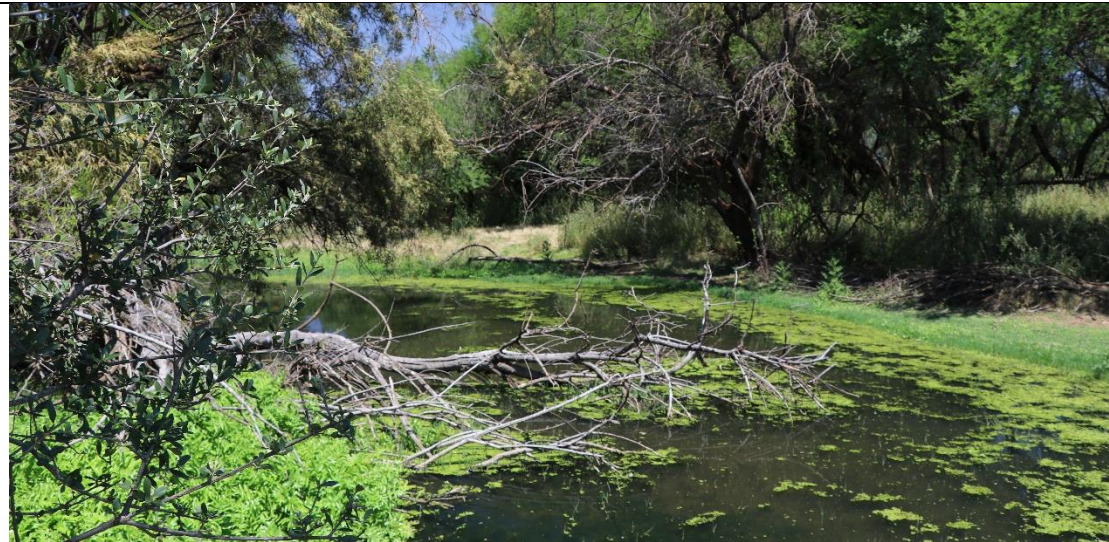
Another view of the stream, note again prominent wetland conditions.

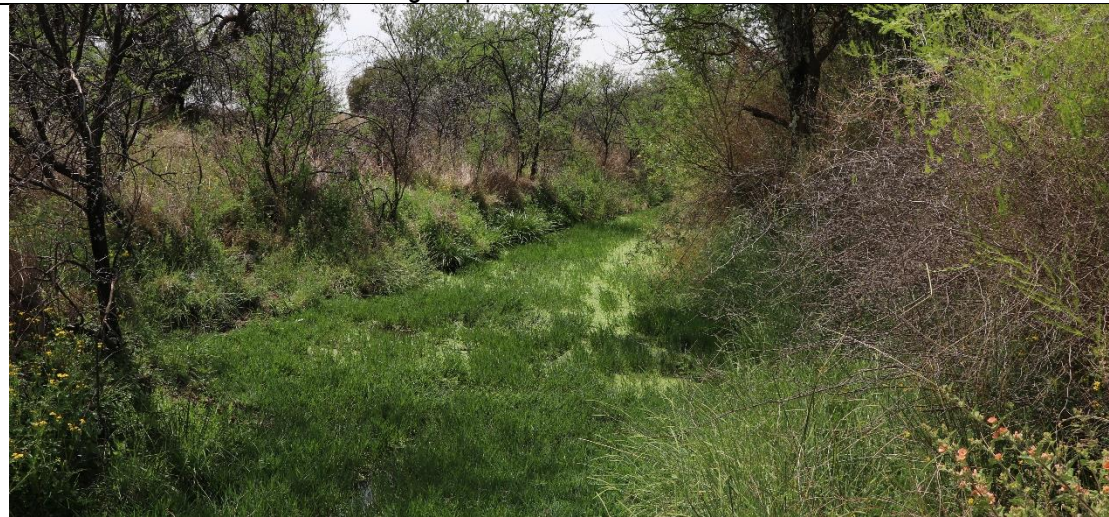
View of the stream at its northernmost section within the MOSS. Note that wetland conditions are still present.

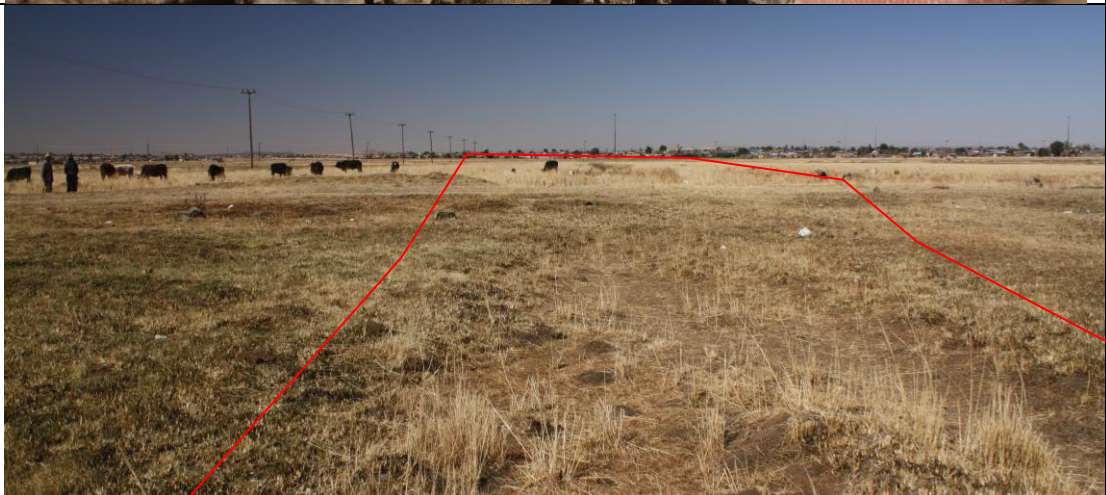
View of the central portion of the wetland area. Lower lying portions (red) contain wetland conditions on a seasonal basis. Note also grazing by domestic stock and the short grass layer.

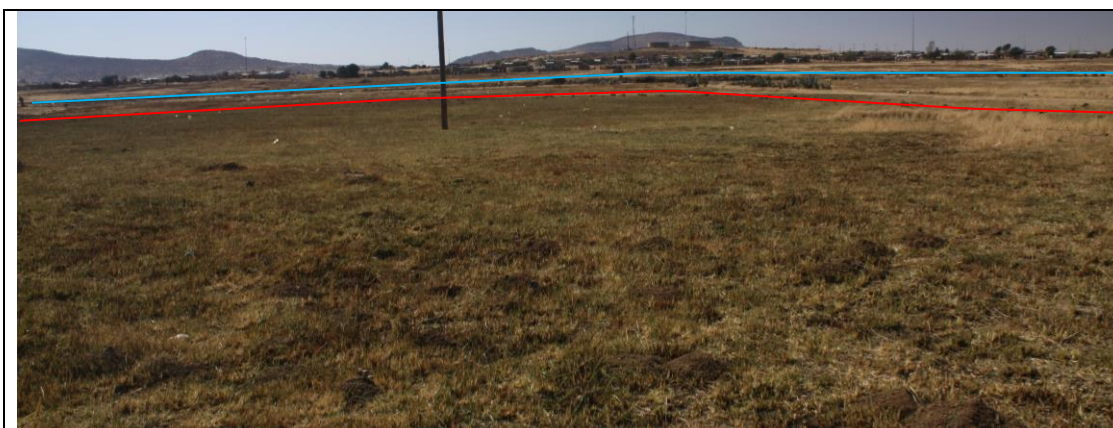
View of the wetland area (red). The Klein-Modder River is indicated in the background (blue).

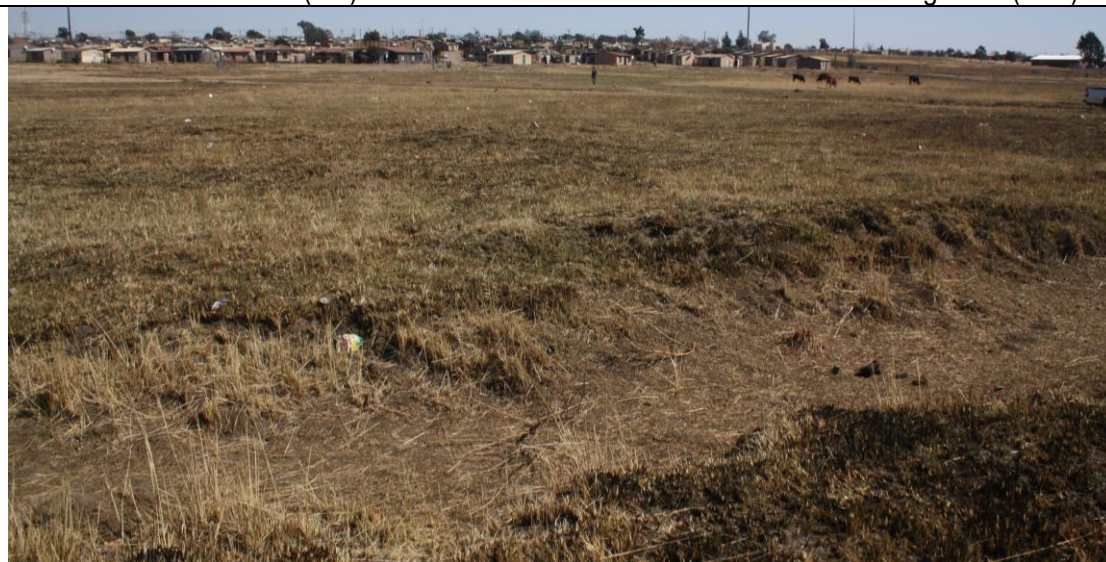
View of the wetland area with a portion of the drainage canal visible in the foreground. Wetland conditions are also present here. Note also the adjacent residential area.

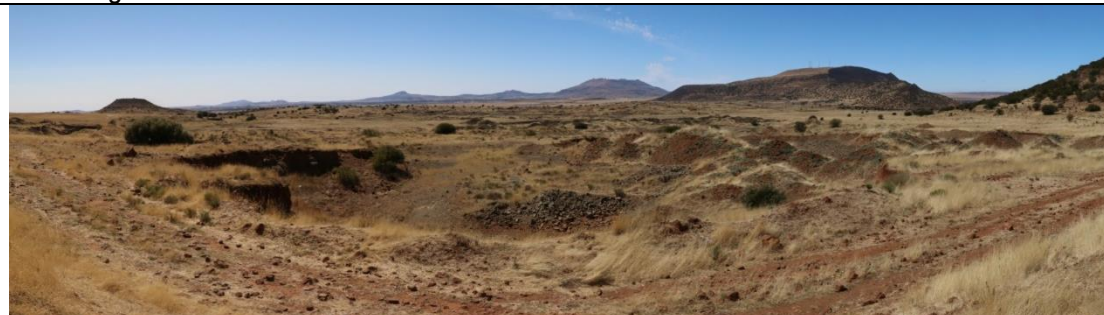
View of the quarry area which also encroaches into the wetland and cause severe degradation of it.

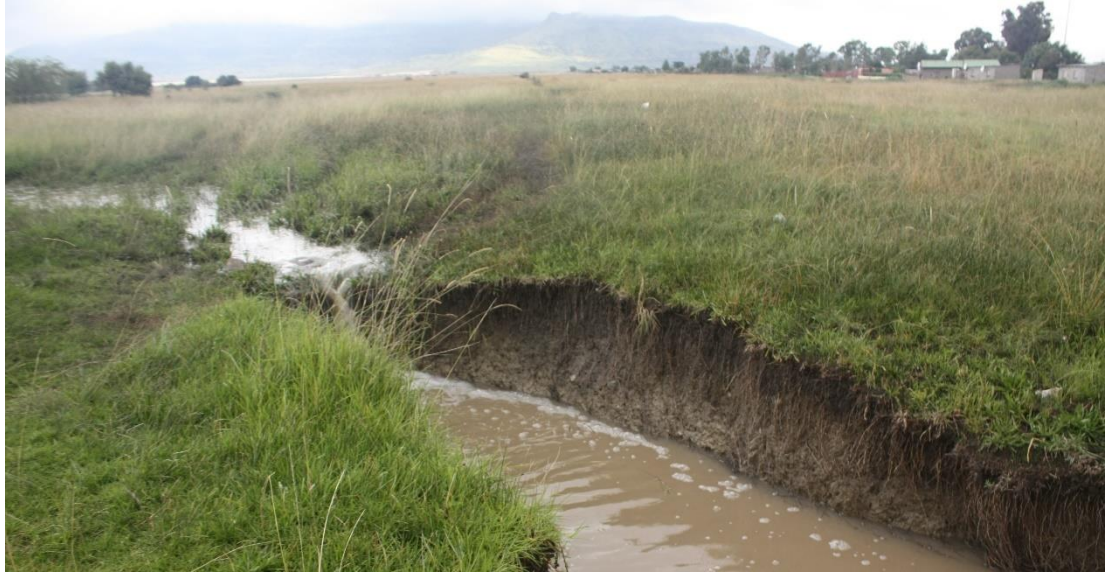
Upstream view of the Sepane River. Note extensive erosion being caused by an increased storm water runoff.

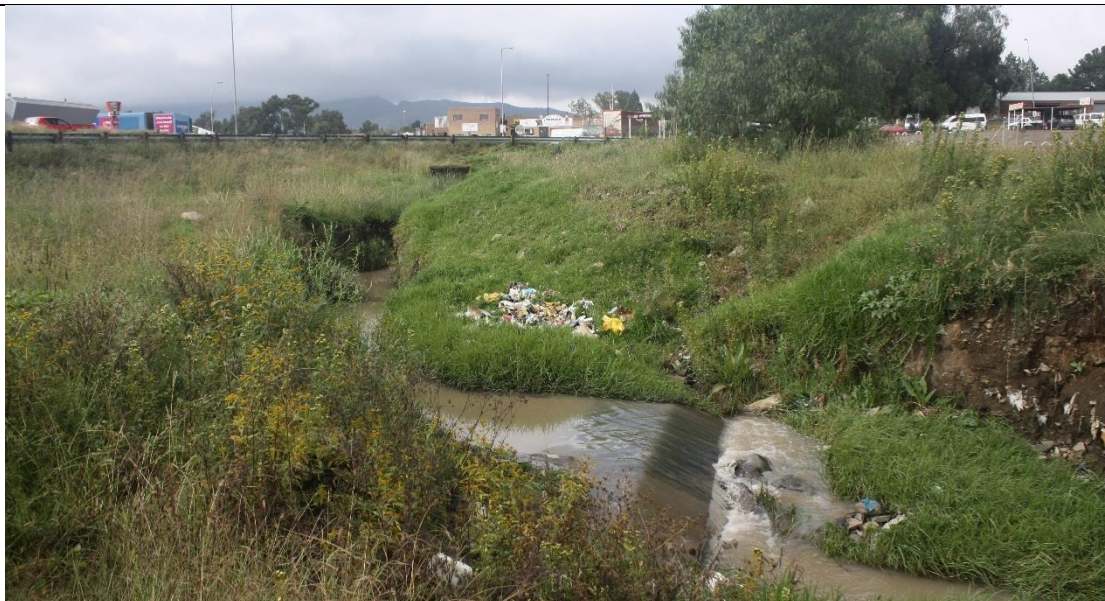
View of the Sepane River within the urban area. Severe modification of the stream is clearly evident. Note the concrete structure in the streambed and rubbish dumping on the banks.

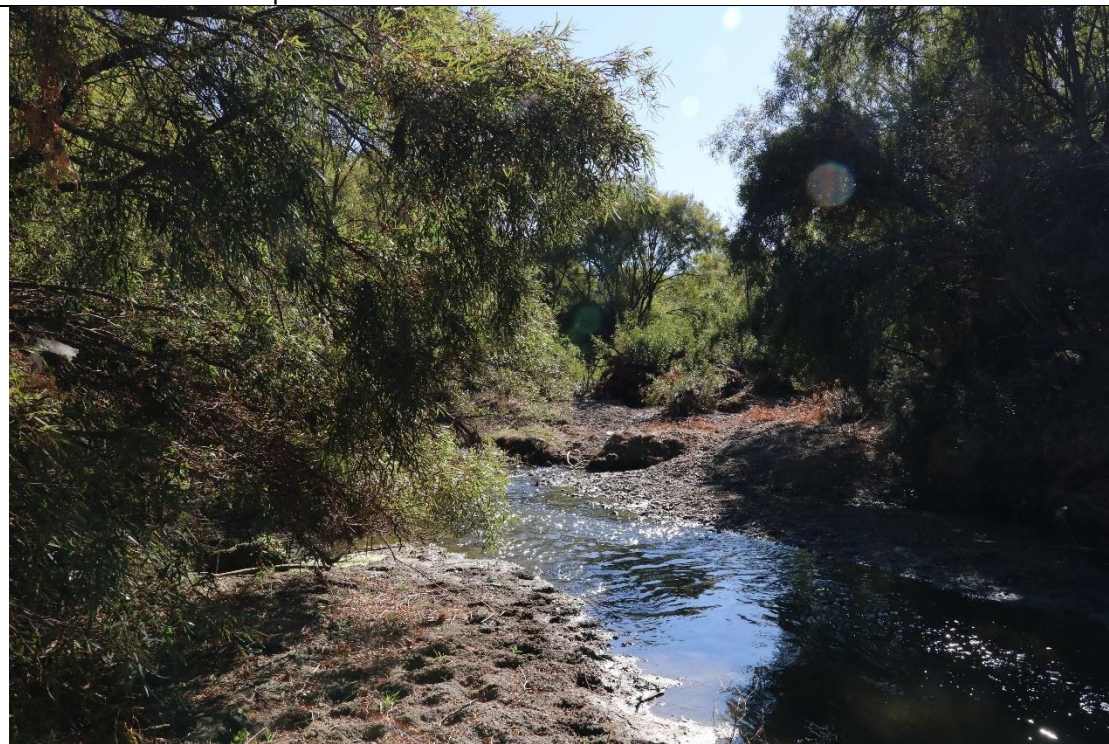
View of the Sepane River where it passes through the moss to the west of the urban area. Here it is evidently in a much better condition.

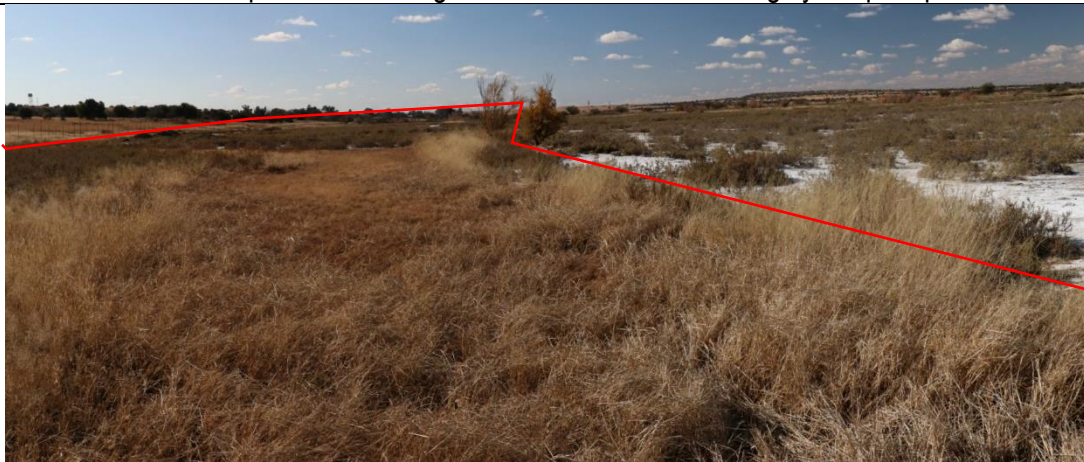
Historical salt mining (red) has caused visible modification of the natural vegetation composition.

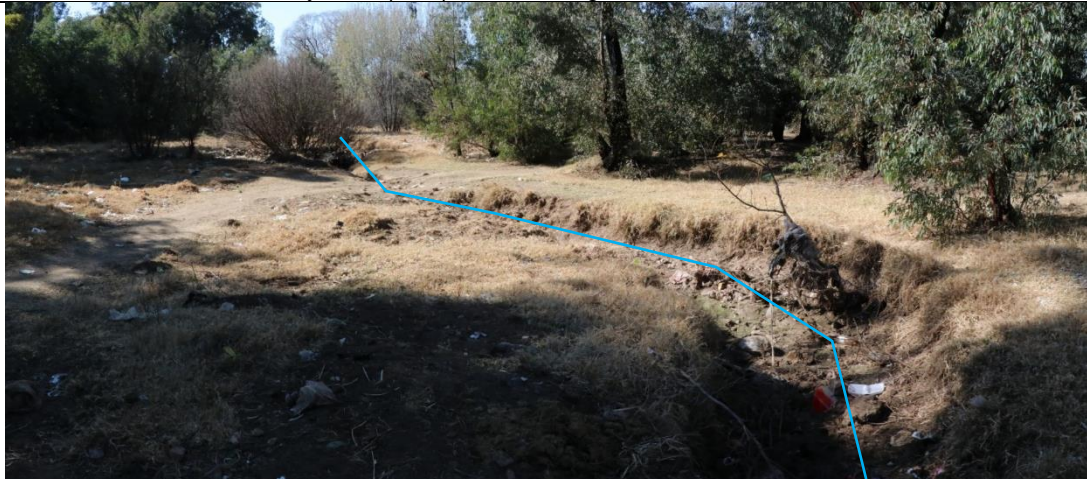
View of the stream (blue) where it flows through the town. Here it is visibly degraded, note also extensive exotic trees.

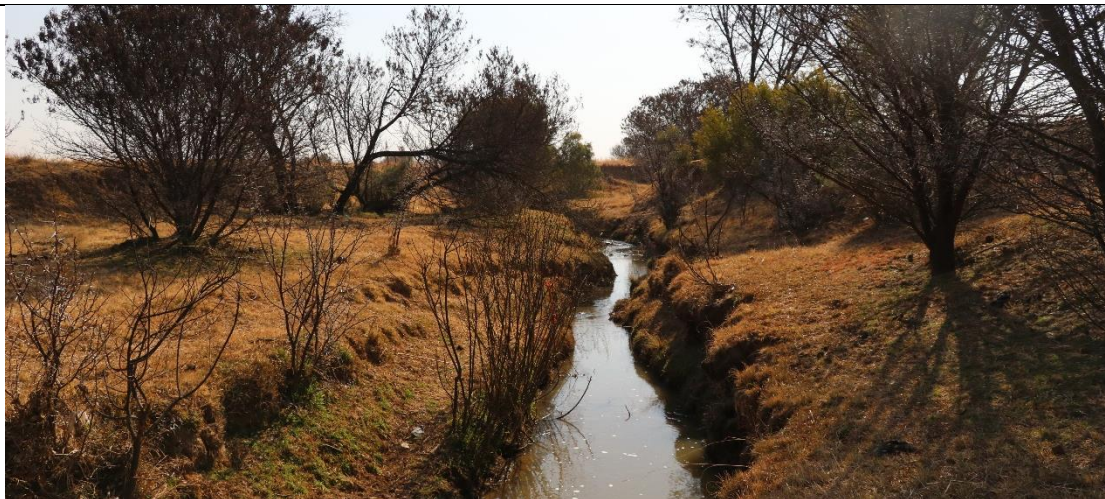
View the stream downstream of the town. Note increased flow as a result of the discharge of the WWTW and also exotic trees lining the banks.

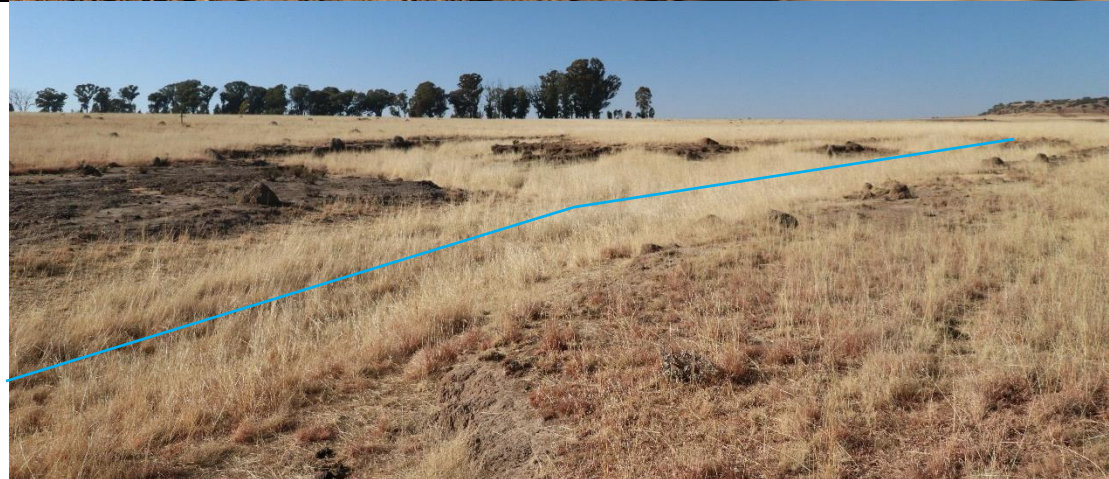
View of the wetland system where a channel is largely absent. However, note significant erosion and which is clearly leading to channel formation.

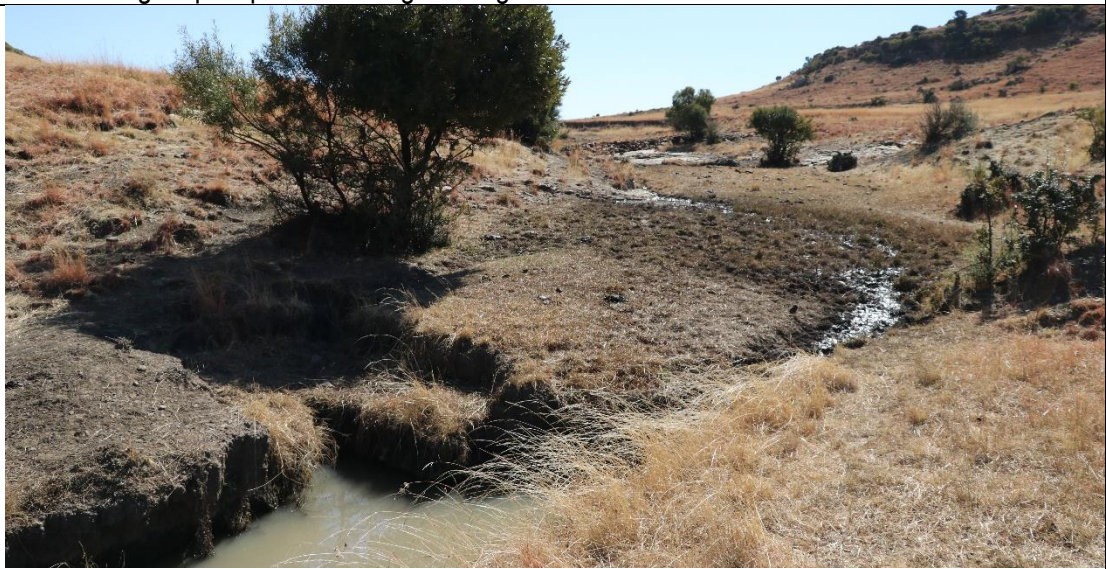
High levels of trampling within the stream cause extensive erosion.
